1234 Kahumanu Ave, Puna Kai Unit 261, Paradise, HI 96700

Inspection prepared for: Sample Report

Date of Inspection: 2/9/2016 Time: 9:30 AM

Inspector: Michael J Lagana

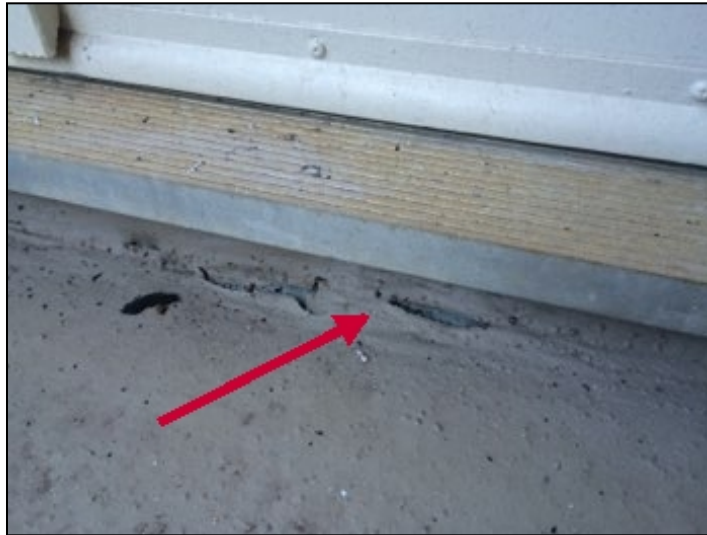
- Damaged waterproof covering at master bedroom lanai. Contact the HOA to evaluate.

Damaged waterproof deck coating at master bedroom lanai.

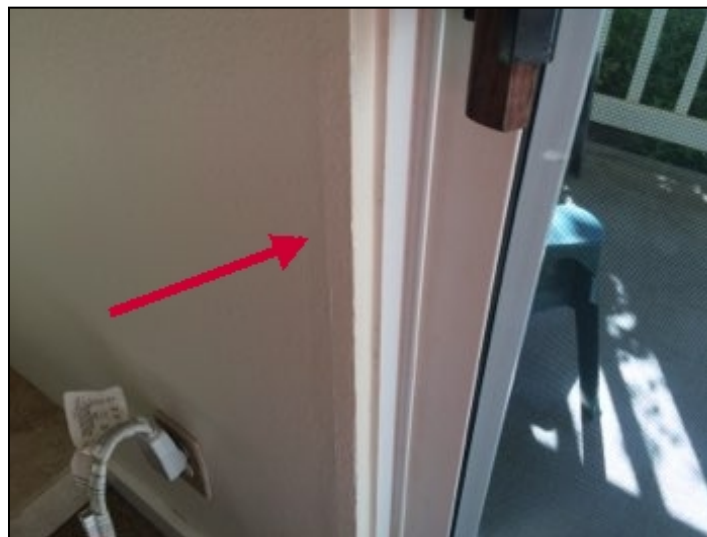
Minor drywall damage at living room lanai.

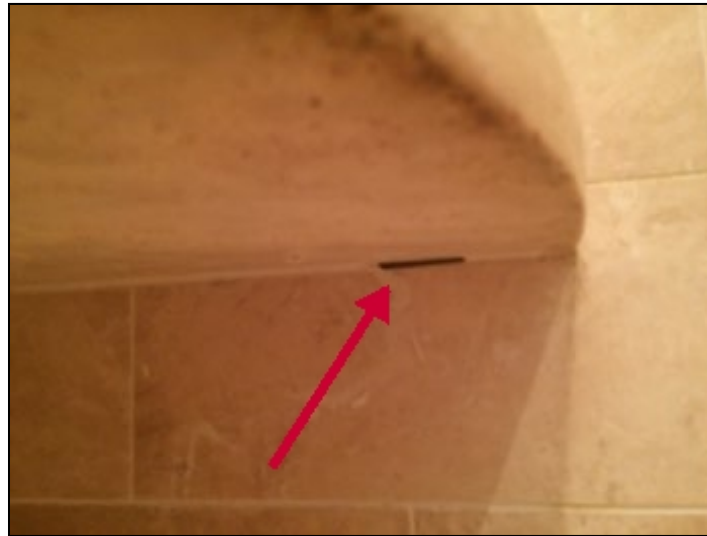
- Missing grout under master bathroom seat at shower. No other defects observed.

Missing grout under seat at master bathroom shower.

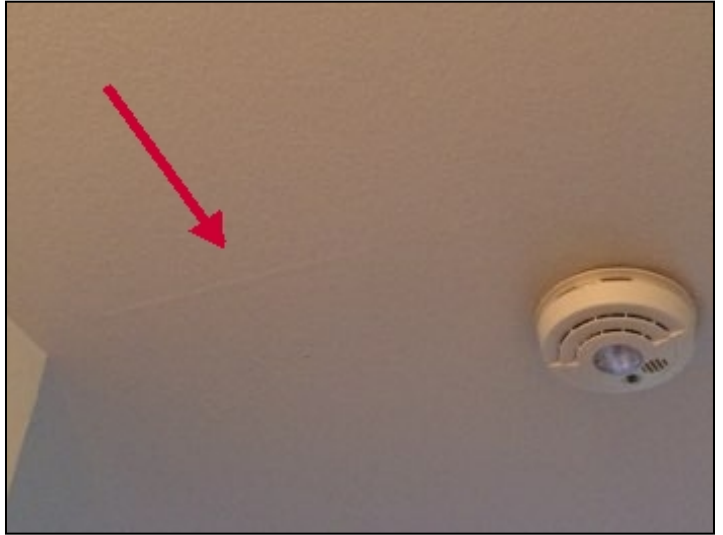
Master bedroom ceiling defect.

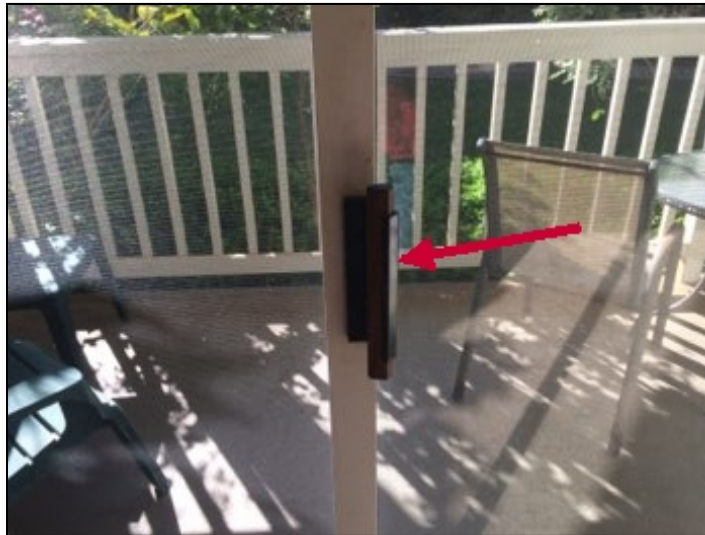
Loose handle at living room sliding glass door.

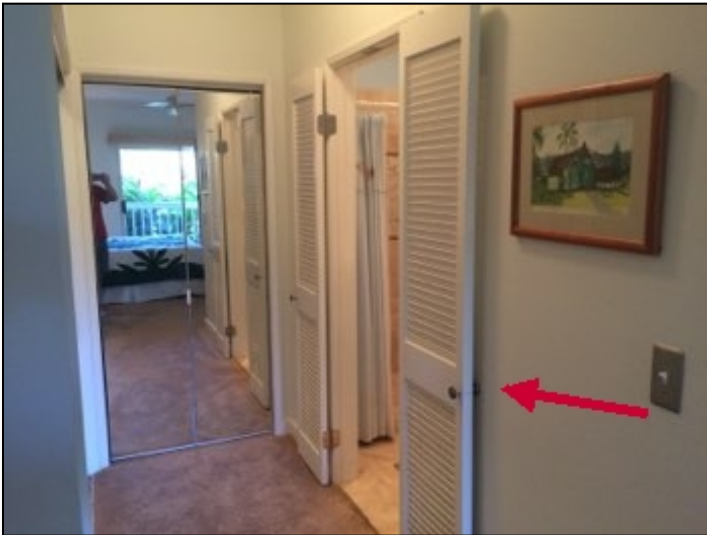
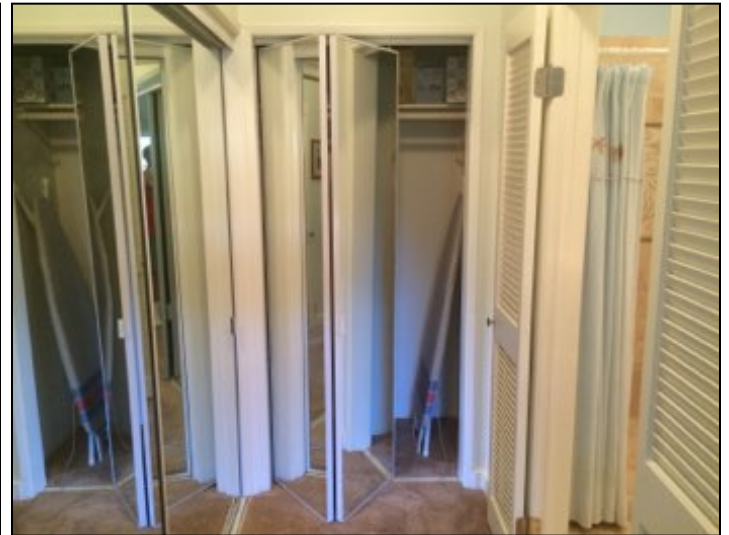
- Master bathroom louvered doors knobs hit drywall, no door stops.
- Mirrored bi-fold doors drag on floor. Difficult to operate.

No door stops at doors to master bathroom. Mirrored bifold doors drag on floor. Difficult to operate.

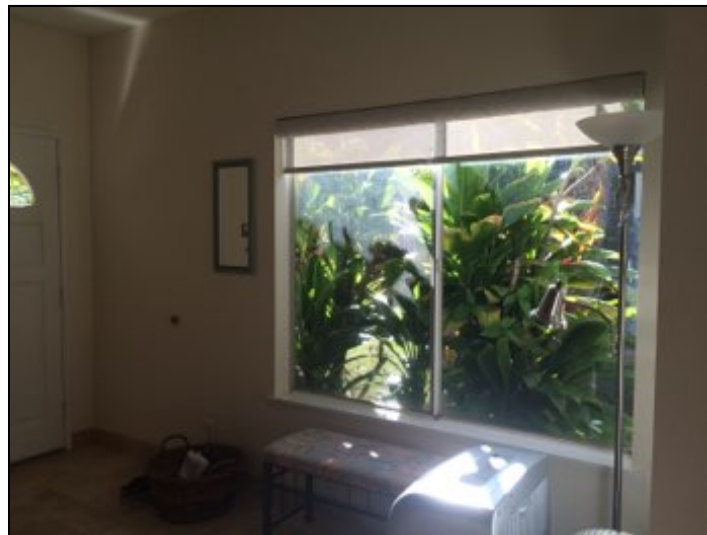
- MAINTENANCE: Cleaning and lubrication is recommended to window components to ensure smooth operation.
- Window at dining room did not operate smoothly.

Dining room window difficult to operate.

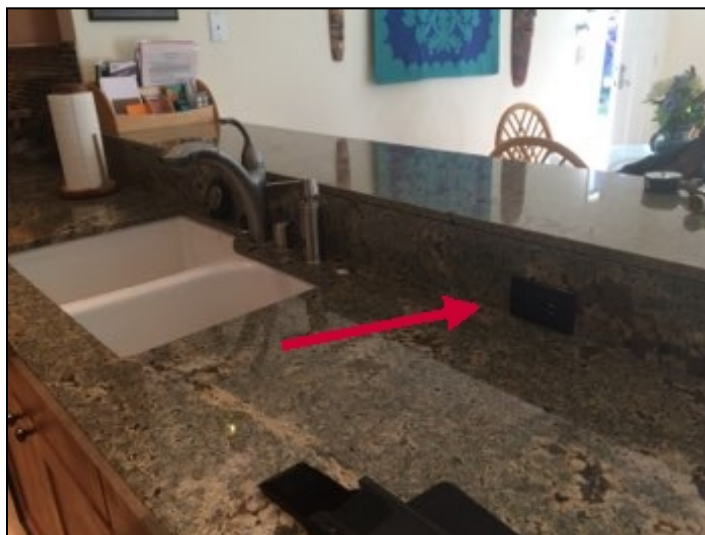
- Receptacles adjacent to kitchen sink not GFI protected.

Receptacles adjacent to kitchen sink not GFI protected.

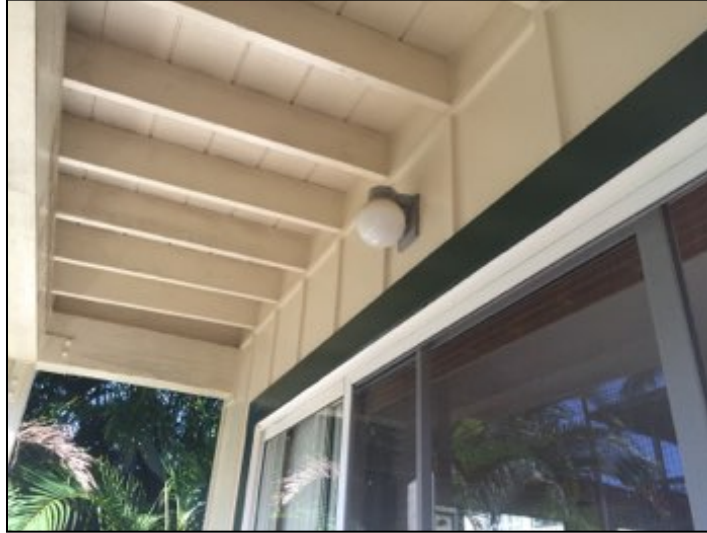
- Probable dead light bulb at living room lanai was observed. Replace bulb and test switch. If fixture not functioning normally, contact a licensed electrical contractor to evaluate.

Replace light bulb and test switch at living room lanai.

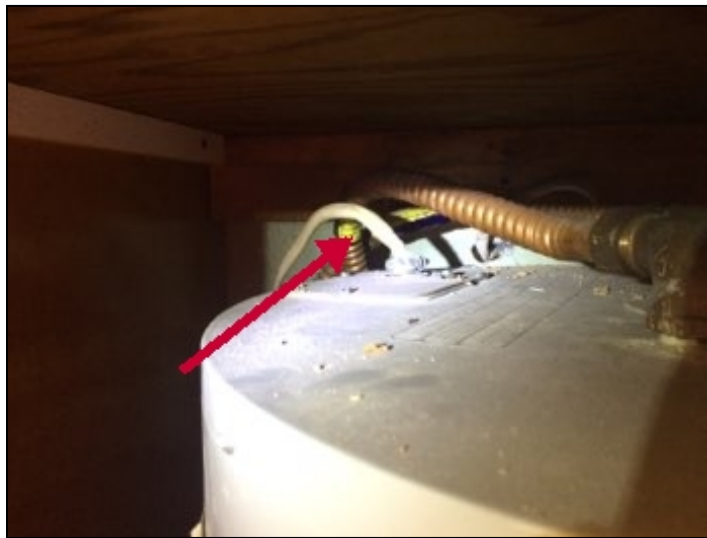
- Wire to water heater should be in protective conduit. Contact a licensed electrical contractor to repair.

Unprotected wiring at water heater.

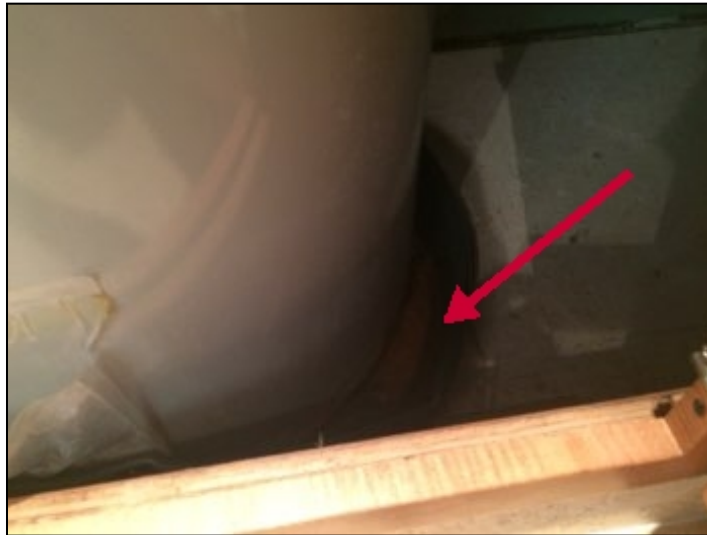
- Corrosion at base of water heater and water in plastic pan below water heater. Contact a licensed plumbing contractor to evaluate.

Corrosion, water in pan at water heater.
